SMM SHIP EVALUATION

Hull Structure Rating and Onboard Inspection Program

M/V DEMO

IMO No.: 9999999

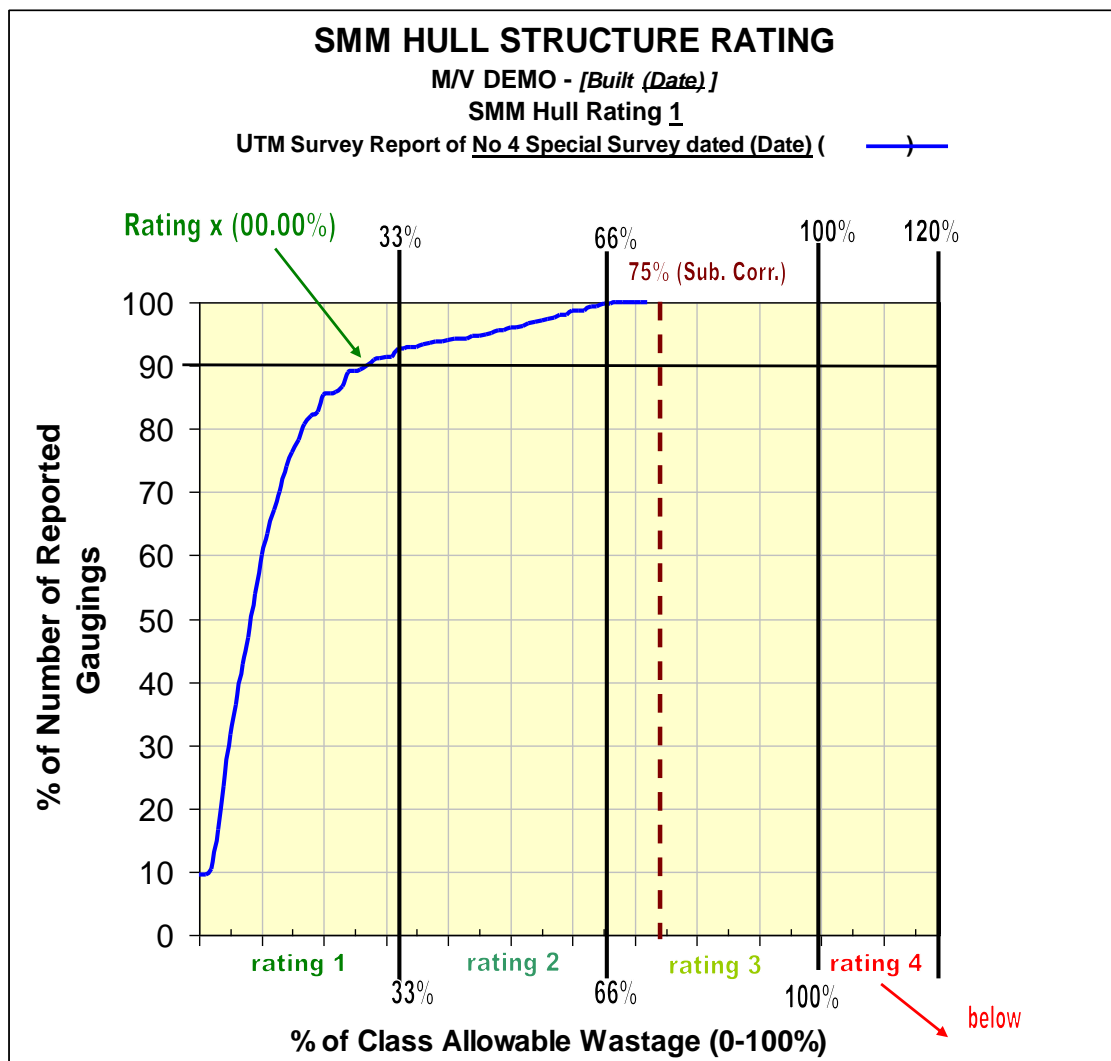
Hull Structure Rating	2						
Maximum percentage of Class Allowable Wastage found in 90% percent of the Total Number of Reported Gaugings .(MWP 90%)	33.47%						
The worst Overall Max. Wastage	64%						
Other Max. %'s of Class Allowable Wastages are shown below:							
10%	20%	30%	40%	50%	60%	70%	80%
4.24%	10.08%	13.62%	16.69%	19.52%	22.48%	24.69%	27.97%

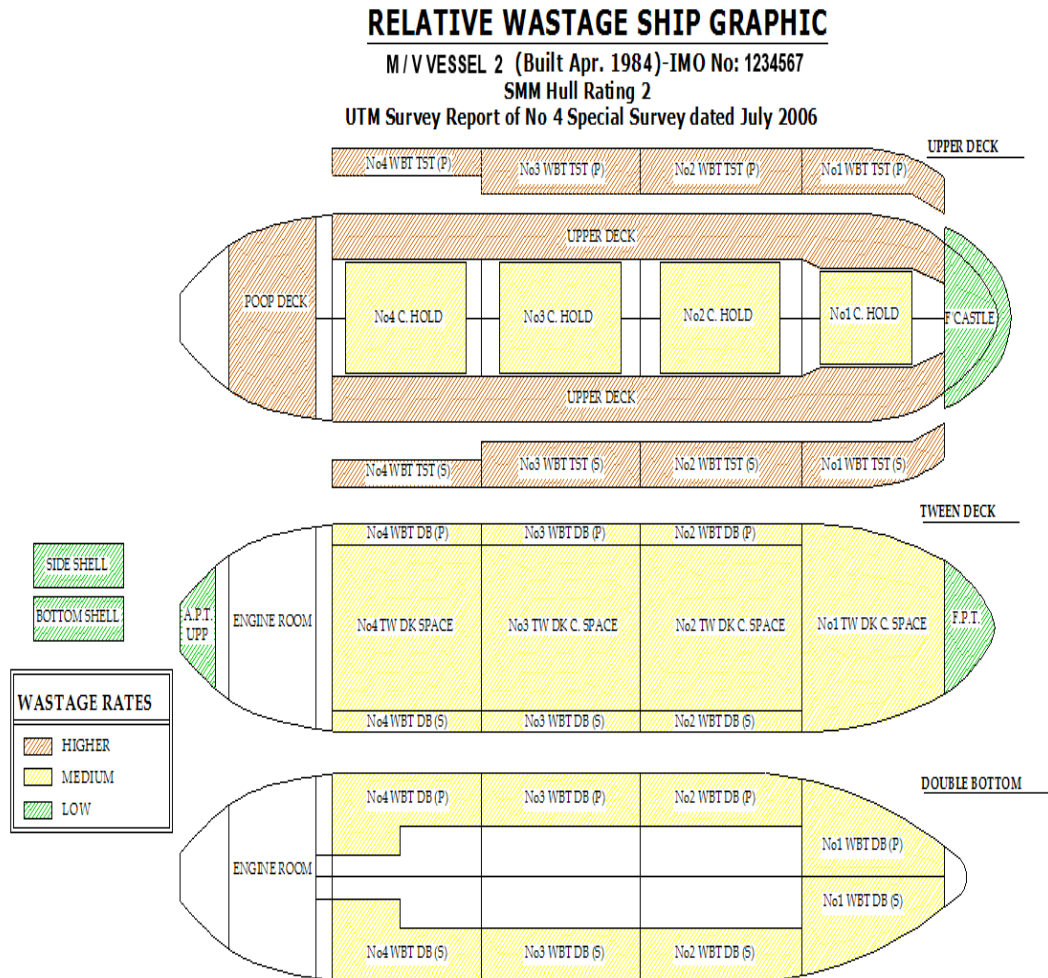
Relative Wastage Ship Graphic

NOTES: The Wastage Rates indicated with the three different colors are relatively chosen for each individual ship. The colors are not meant to be used for comparison of two different vessels. The dark color does not necessarily indicate bad condition but shows which compartments in the particular ship lead the way to higher wastage.
